Emergency Landing of American Airlines Flight 268

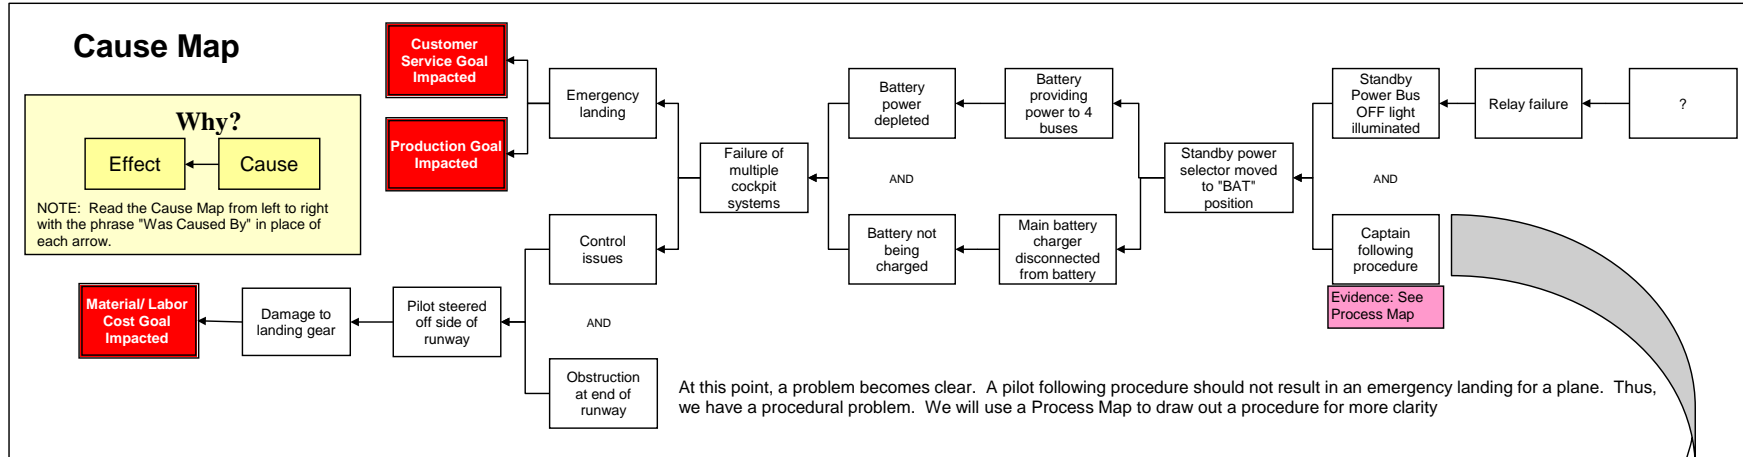
The failure of the cockpit systems was caused by the battery power being depleted and not being recharged. This occurred because the battery was powering four systems, and was disconnected from the main battery charger. This happened because the standby power selector switch was moved to the "BAT" (or battery) position. The standby selection switch was moved to battery because that is what procedure called for when the "Standby Power Bus OFF" light is illuminated. The light was illuminated due to a relay failure, of unknown cause.

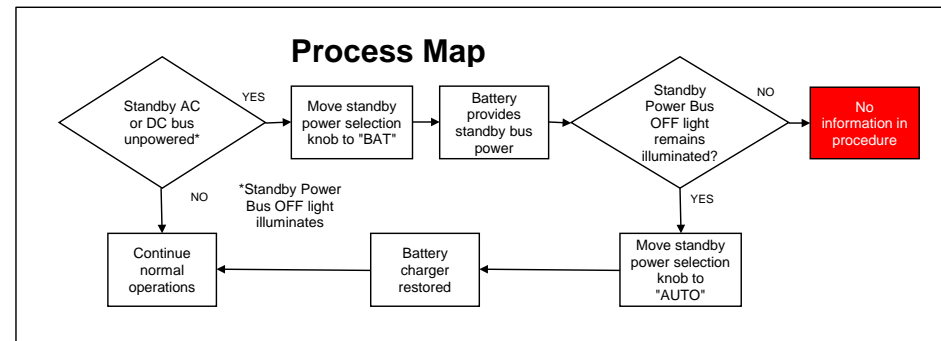
Written in a paragraph, it can be difficult to see where the issue is. But if we put it in a Process Map, we see a decision box for "Standby Power Bus OFF light remains illuminated". If the answer is yes, we follow the procedure outlined above. But if the answer is no, there is no procedure to follow. This is the position the pilot of Flight 268 was in. The "Standby Power Bus OFF" light went out, so the pilot left the standby power selection knob on "BAT". This drained the battery, resulting in the failure of various
