How an Unchecked Assumption Brought Down a Bridge (The Collapse of the I-35 Bridge in Minneapolis)

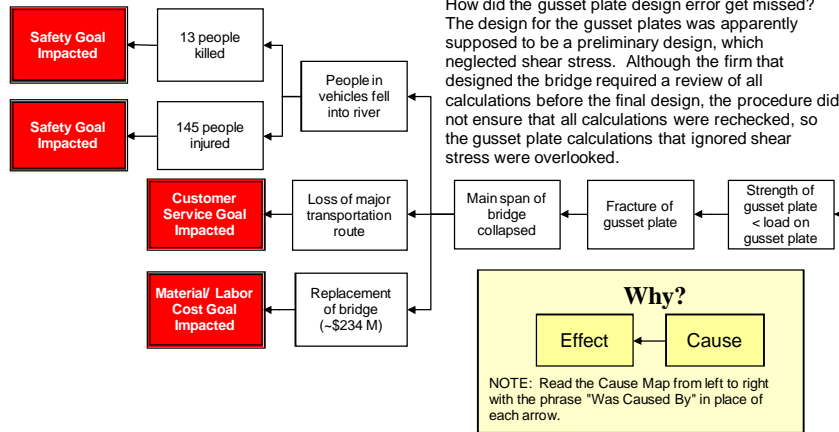
On August 1, 2007, the I-35 bridge over the Mississippi River in Minneapolis, Minnesota collapsed during evening rush hour, killing 13 and injuring at least 145. During the National Transportation Safety Board's investigation, it was discovered that the gusset plates (the riveted metal plate that joins several structural members) were designed with inadequate load capacity. At the time of the bridge collapse, the load on the gusset plate that failed was higher than usual, due to construction materials and equipment concentrated on the deck over the location of the gusset plate and rush hour traffic slowed by the construction. In addition to these weights, the dead load (weight of the bridge structure) had increased by more than four million pounds due to improvements made to

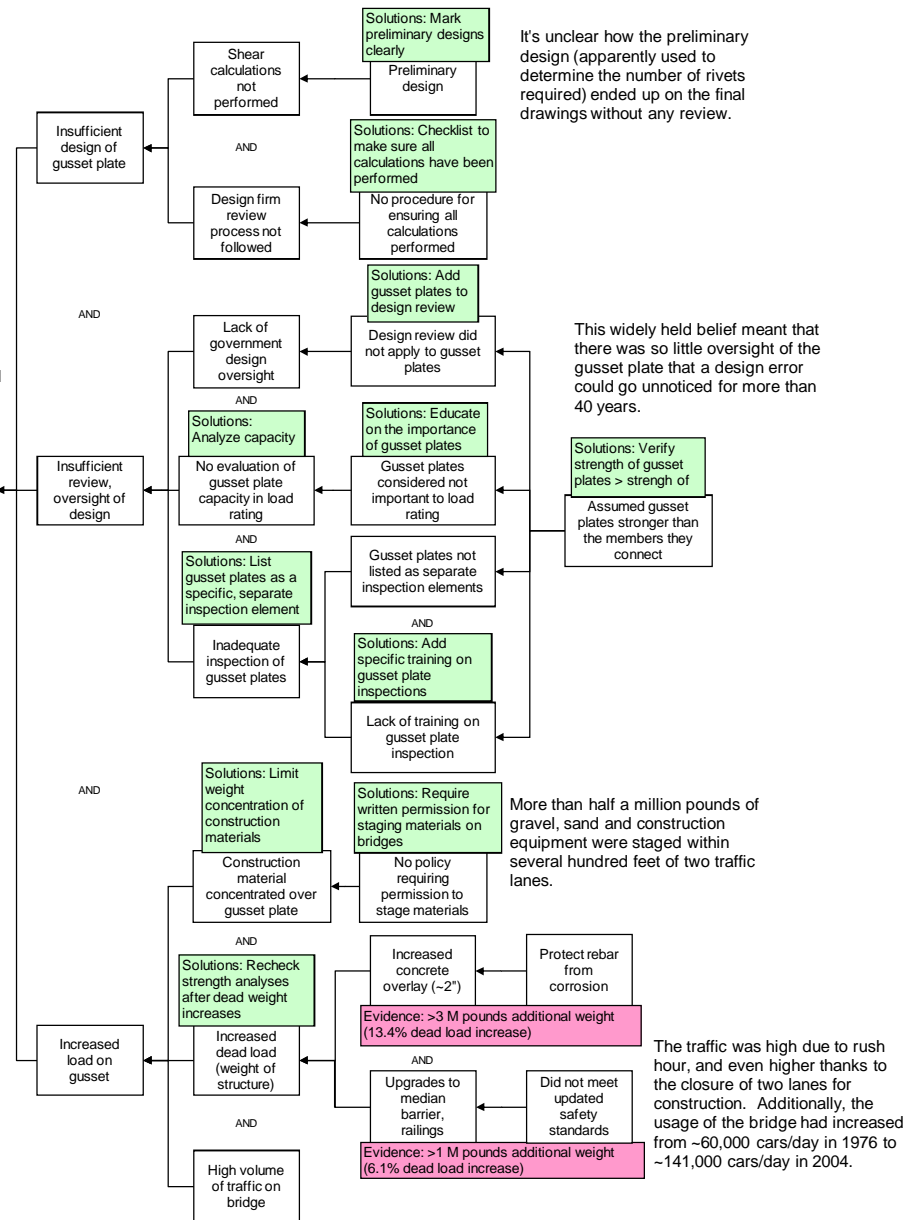
It's unclear how the preliminary design (apparently used to determine the number of rivets required) ended up on the final drawings without any review.

This widely held belief meant that there was so little oversight of the gusset plate that a design error could go unnoticed for more than 40 years.

More than half a million pounds of gravel, sand and construction equipment were staged within several hundred feet of two traffic lanes.

The traffic was high due to rush hour, and even higher thanks to the closure of two lanes for construction. Additionally, the usage of the bridge had increased from ~60,000 cars/day in 1976 to ~141,000 cars/day in 2004.
