Step 1. Problem Outline

Toyota/Lexus Model Year 2004-2010 Recall

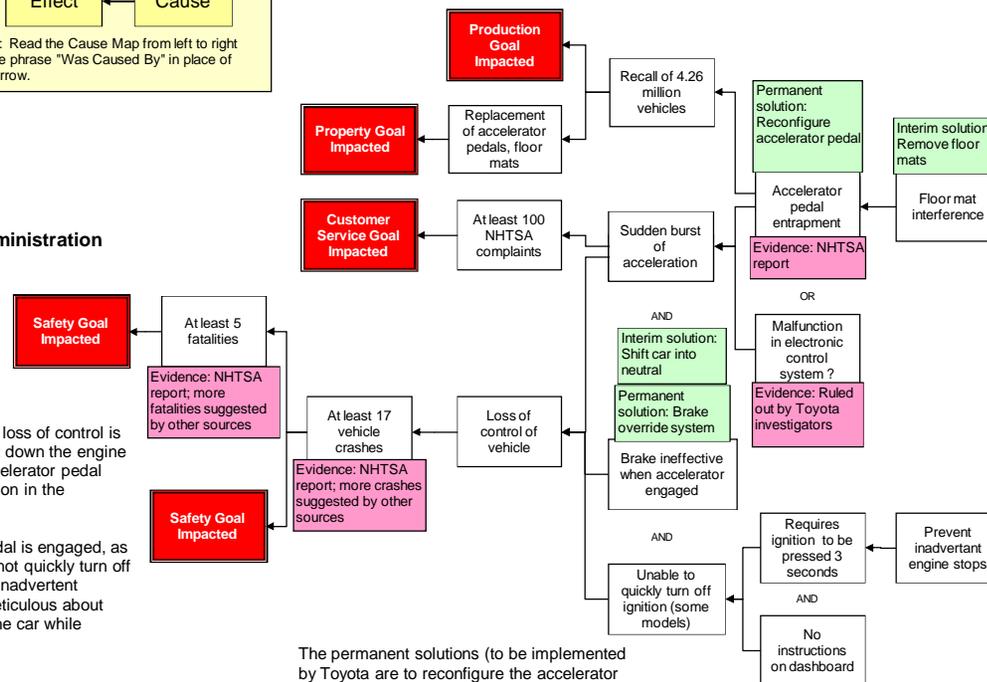
Step 2. Cause Map Detail Level

The fatalities are caused by vehicle crashes resulting from a loss of control of the vehicle. The loss of control is caused by a sudden surge of acceleration, inability to brake, and sometimes an inability to shut down the engine of the car. Toyota says the sudden bursts of acceleration are caused by entrapment of the accelerator pedal due to interference from floor mats. Toyota refutes the possibility that there may be a malfunction in the electronic control system, saying it's been ruled out by Toyota research.

The vehicles are unable to brake because the brake is non-functional when the accelerator pedal is engaged, as it is in these cases. Additionally, owners whose models are equipped with keyless ignition cannot quickly turn off their ignition. These models require the ignition button to be pressed for 3 seconds to prevent inadvertent engine stops, and the instructions are not posted on the dashboard, so owners who weren't meticulous about reading (or remembering) instructions from the owners' manual may not know how to turn off the car while moving at very quick speeds.

The permanent solutions (to be implemented by Toyota) are to reconfigure the accelerator pedal, replace the floor mats, and install a brake override system which will allow the brakes to function even with the accelerator pedal engaged. In the meantime, Toyota has asked owners to remove floor mats, and has put out guidance that drivers who are in an uncontrolled acceleration situation should shift the engine into neutral, which will disengage the engine and allow the brake to stop the car.
