Hyatt-Regency Walkway Bridge Collapse
July 17, 1981
Kansas City, MO

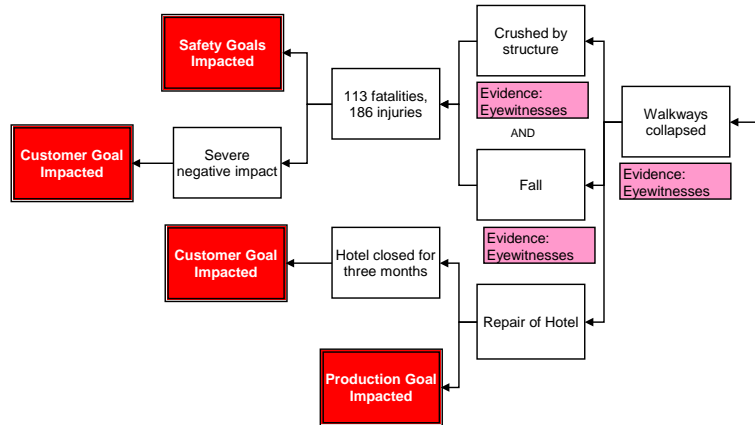
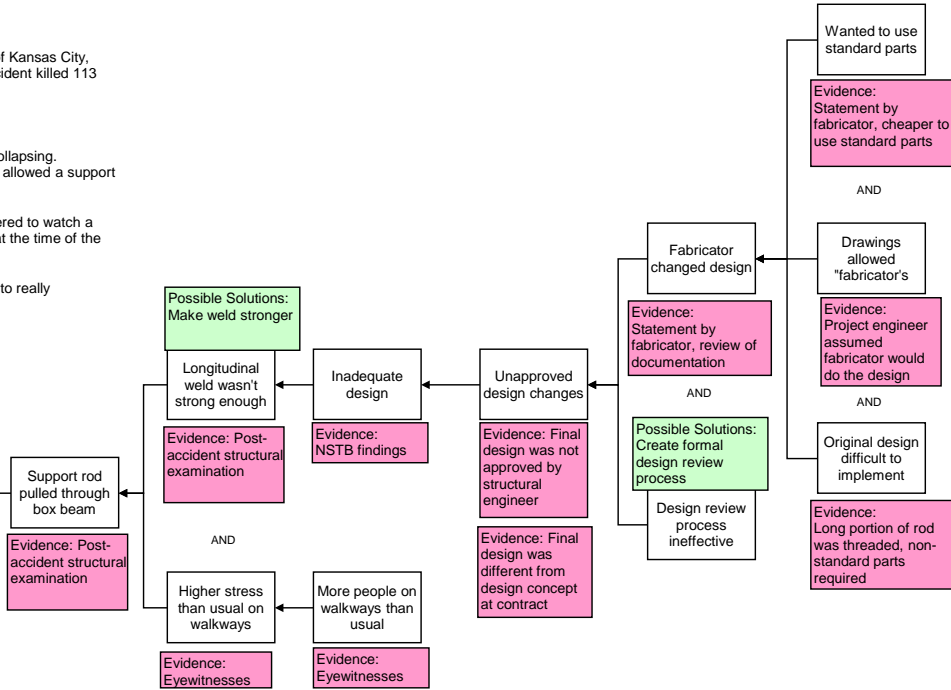
A root cause analysis of this accident shows that there were a number of causes that contributed to the walkways collapsing. Investigation into the accident shows that the structural design of the walkway was inadequate. A weld failed which allowed a support rod to pull through the box beam and the walkways fell.

In this case, it appears that the design was changed without approval of the structural engineer. This resulted from a communication error between the fabricator and the structural engineer. The structural engineer sent a sketch of a proposed walkway design to the fabricator, assuming that the fabricator would work the details of the design himself. The fabricator assumed the sketch was a finalized drawing.

The fabricator then picked standard parts to fit the sketch. This resulted in a significant change from the original design and dramatically decreased the load bearing capacity of the walkways.

The original design called for continuous hanger rods (a non-standard part that would have needed to be manufactured) that passed through the fourth floor walkway beam box to the second floor walkway, resulting in the ceiling connecting supporting the weight of both walkways. The fabricator changed the design to use two shorter rods (standard parts) which resulted in the fourth floor walkway supporting the weight of the second floor walkway, which it wasn't designed to handle.
