# The Phillips 66 Plant Explosion Pasadena, TX October 23, 1989

On October 23, 1989, the Phillips 66 Petroleum Chemical Plant near Pasadena, Texas, then producing approximately 1.5 billion of high-density polyethylene (HDPE) plastic each year, suffered a massive series of explosions. 23 died and hundreds were injured in an explosion that measured at least 3.5 on the Richter scale and destroyed much of the plant.

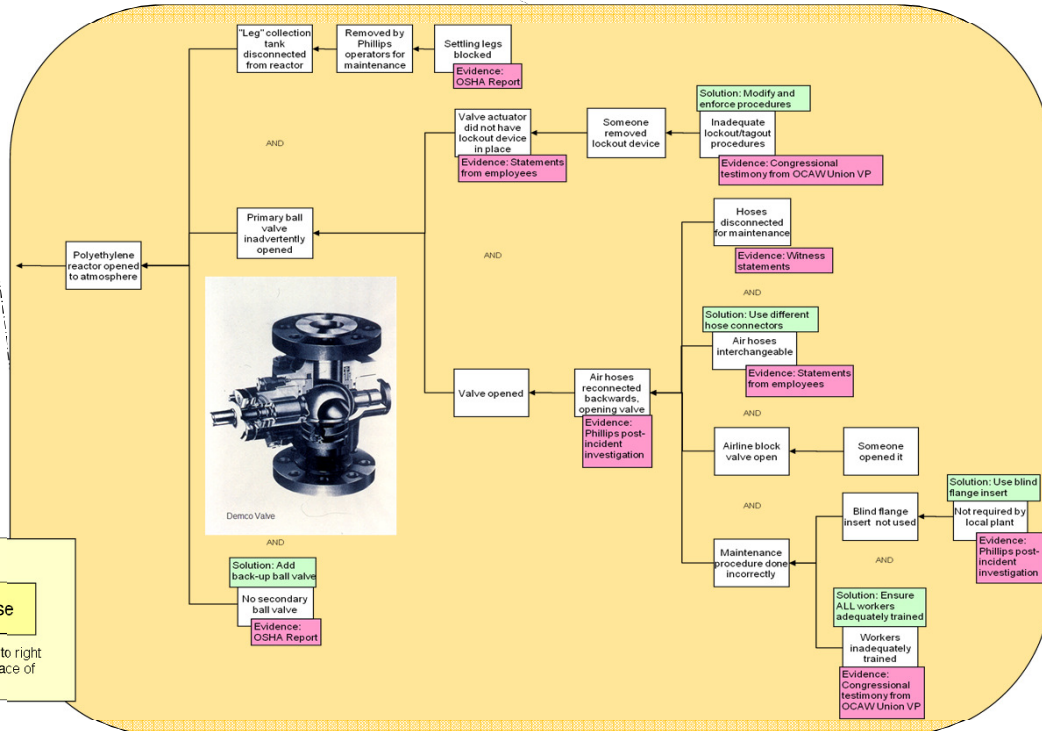
## Step 2. Cause Map High and Intermediate Levels

Looking at the Phillips 66 Explosion Cause Map, one can see how a series of procedural errors occurred that fateful day. Contract workers were busy performing a routine maintenance task of clearing out a blockage in a collection tank for the plastic pellets produced by the reactor. The collection tank was removed, and work commenced that morning. However, at some point just after lunch, the valve to the reactor system was opened, releasing an enormous gas cloud which ignited less than two minutes later.

The subsequent OSHA investigation highlighted numerous errors. First, the air hoses used to activate the valve pneumatically were left near the maintenance site. When the air hoses were connected backwards, this automatically opened the valve, releasing a huge volatile gas cloud into the atmosphere. It is unknown why the air hoses were reconnected at all. Second, a lockout device had been installed by Phillips personnel the previous evening, but was removed at some point prior to the accident. A lockout device physically prevents someone from opening a valve. Finally, in accordance with local plant policy but not Phillips policy, no blind flange insert was used as a backup. The insert would have stopped the flow of gas into the atmosphere if the valve had been opened. Had any of those three procedures been executed properly, there would not have been an explosion that day. According to the investigation, contract workers had not been adequately trained in the procedures they were charged with performing.

Additionally, there were significant design flaws in the reactor/collector system. The valve system used had no mechanical redundancies; the single Demco ball valve was the sole cut-off point between the highly-pressurized reactor system and the atmosphere. Additionally, there was a significant design flaw with the air hoses, as alluded to earlier. Not only were the air hoses connected at the wrong time, but there was no physical barrier to prevent them from being connected the wrong way. This is the same reason North American electrical plugs are mechanically keyed and can only be plugged in one way. It can be bad news if connected incorrectly! Connecting the air hoses backward meant the valve went full open, instead of closed. Both of these design flaws contributed to the gas release, and again, this incident would not have occurred if either flaw was absent.
