What	Problem(s)	Bridge collapse
When	Date	August 1, 2007
	Time	6:05 p.m.
	Differences	Evening rush hour, roadwork underway
Where	Physical location	Minneapolis, Minnesota
Impact to Goals		
Safety		13 people killed 145 people injured
Service		Loss of major transportation route
Property		Replacement of bridge (\$234 M)

I-35 BRIDGE COLLAPSE

How an Unchecked Assumption Brought Down a Bridge

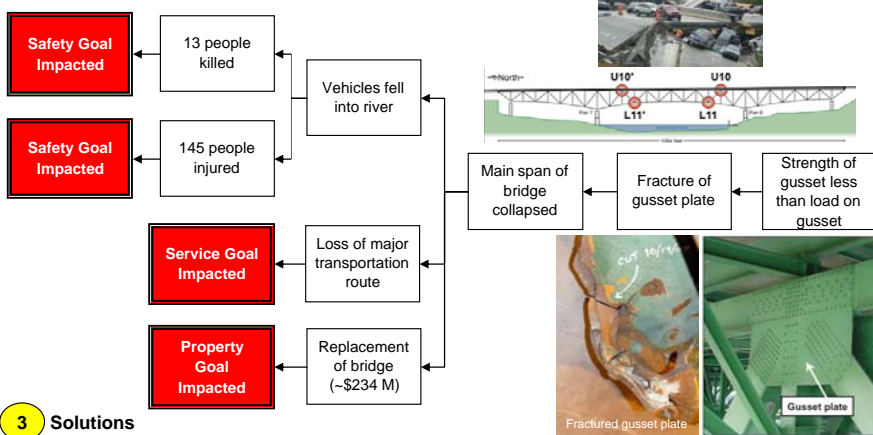
More Detailed Cause Map - Add detail as information becomes available.

Basic Cause-and-Effect
The safety goal was impacted because 13 people were killed when the bridge collapsed. The bridge collapsed due to a fractured gusset plate, which was designed with insufficient load capacity.

The gusset plate was under-designed because shear calculations were not performed. The error wasn't noticed during the firm's review process, by the government, or during load rating evaluations and inspections over the service of the bridge. Why? Because gusset plates just weren't considered to be that important. When correctly designed, they are stronger than the members they connect and so can be omitted from the analysis.

The gusset plate had been under designed from the time the bridge opened. So why did it fail in 2007? The volume of the traffic had increased greatly since the bridge opening, and traffic was particularly high at the time of the collapse thanks to rush hour and road work. The construction materials for the road work were concentrated over the gusset plate, with no oversight. On top of all this, the dead load, or weight of the bridge, had increased by more than 4 million pounds from roadway improvements.
