GROUNDING THE 737'S

Cause Map Emergency Descent of SWA Flt 812

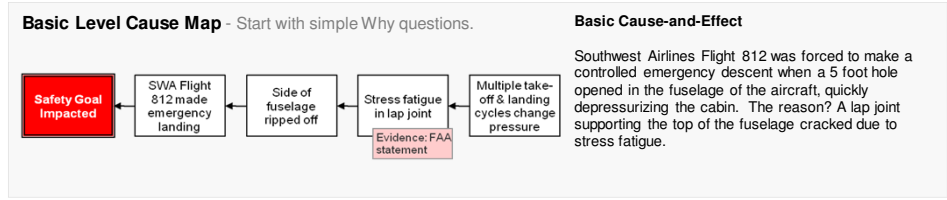
2 Analysis

What	Problem(s)	Emergency descent due to hole in side of plane, Airline fleet grounded
When	Date	April 1, 2011
	Different, unusual, unique	Hole in fuselage
Where	State, city	Across United States
	Unit	Boeing 737-300, -400 and -500 aircraft
	Task being performed	Flying aircraft
Impact to the Goals		
	Safety	Plane made emergency landing
	Safety	80 planes deemed not airworthy
	Cust. Service	670 flights cancelled
	Production	Loss of revenue
	Property, Equip, MIs	Multiple planes have cracks
	Labor	Additional inspections required

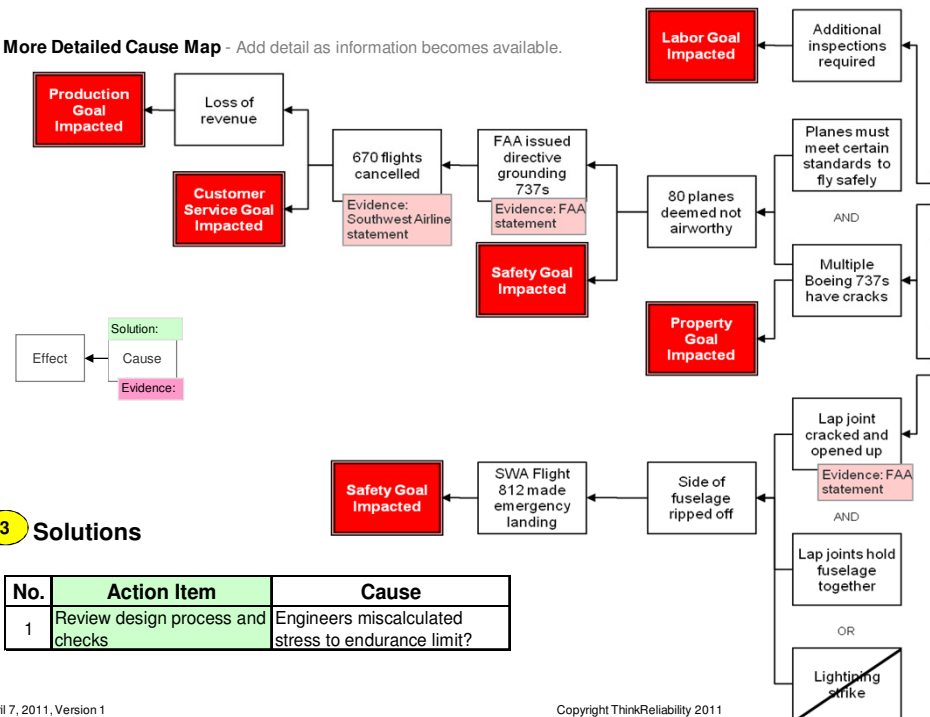
More Detailed Cause Map

While the investigation is still in the early stages, it appears that stress fatigue caused a lap joint near the top of fuselage to fail. Stress fatigue is a well known phenomenon, caused in aircraft by the constant pressurization and depressurization occurring during takeoff and landing. Mechanical engineers would have been well aware of this phenomenon. The S-N curve, which plots a metal's expected lifespan vs. stress, has been used for well over a century.

Just as a car needs preventative maintenance, planes are checked regularly for parts that are ready to fail. However, the crack in lap joint wasn't detected during routine maintenance. Often the design engineers are also set the maintenance schedule, because they hold the expertise needed. The engineers didn't expect the part to fail for at least 20,000 more flight hours. At the moment, it's unclear why that is.

No.	Action Item	Cause
1	Review design process and checks	Engineers miscalculated stress to endurance limit?
