The Phillips 66 Plant Explosion Pasadena, TX October 23, 1989

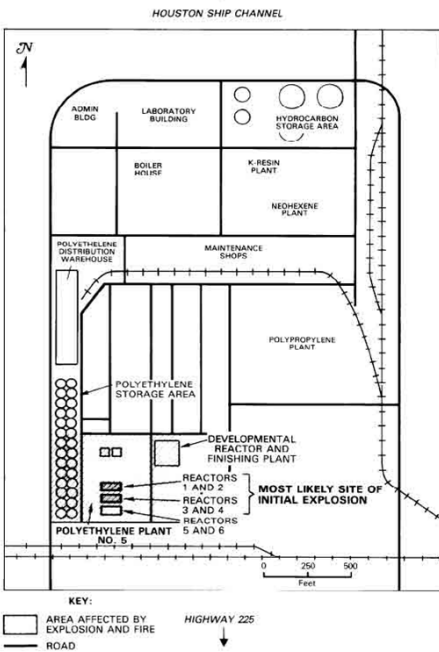
Using the Phillips 66 explosion of 1989 as an example, it is easy to see how numerous efficiency-related decisions snowballed into a catastrophe. Examining different branches of the Cause Map highlights areas where those shortcuts played a role. Some branches focus on how the plant was laid out, how operations were run and how the firefighting system was designed. Arguably, all of these areas were maximized for production efficiency, but ended up being contributing factors in a terrible explosion and hampered subsequent emergency efforts.

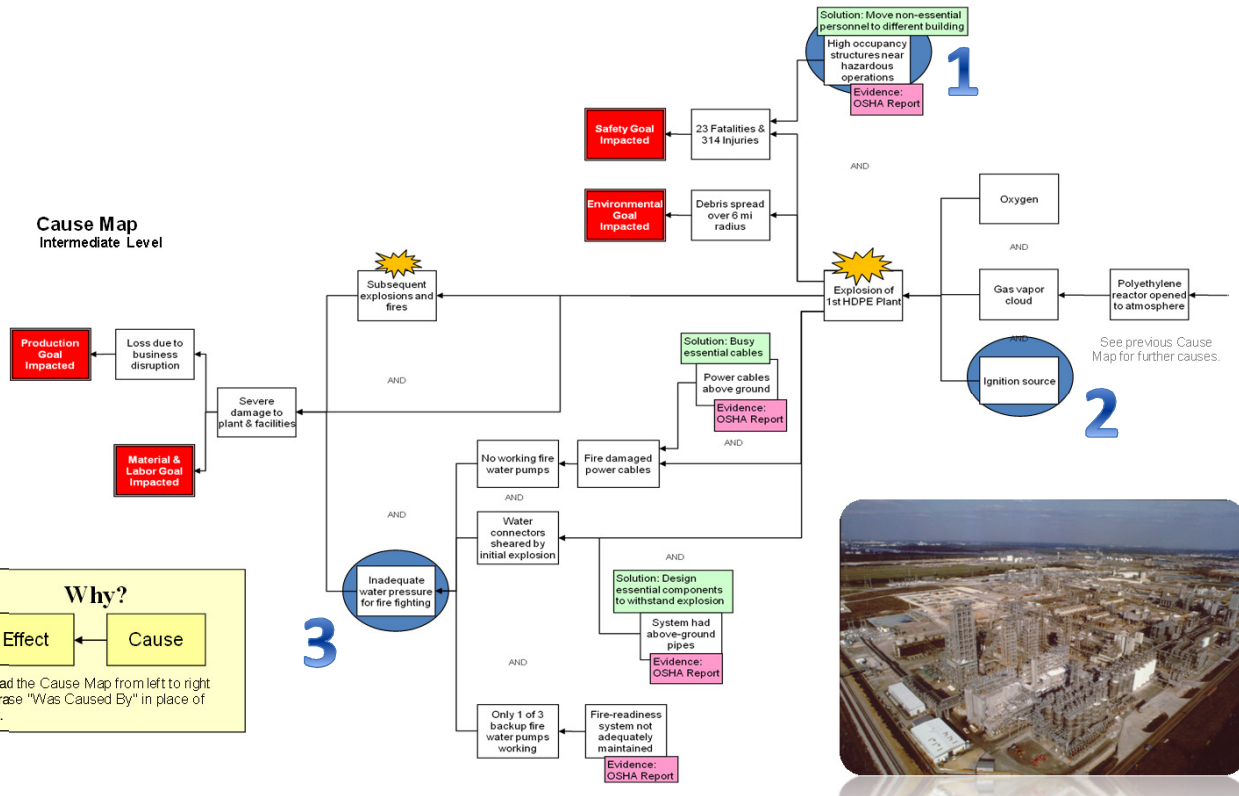
The Cause Map shows that the high number of fatalities was caused not only by the initial explosion. The OSHA investigation following the explosion highlighted contributing factors regarding the building layout. High occupancy structures, such as the control room and administrative building were located unnecessarily close to the reactors and storage vessels. Luckily over 100 personnel were able to escape via alternate routes. But luck is certainly not a reliable emergency plan; the plant should have been designed with safety in mind too.

Nearby ignition sources also contributed to the speed of the initial explosion, estimated to be within 90 to 120 seconds of the valve opening. OSHA cited Phillips for not using due diligence in ensuring that potential sources of ignition were kept a safe distance from flammable materials or, alternatively, using testing procedures to ensure it was safe to bring such equipment into work zones. The original spark source will never be known, but the investigation identified multiple possibilities. These included a crane, forklift, catalyst activator, welding and cutting-torch equipment, vehicles and ordinary electrical gear. While undoubtedly such a large cloud of volatile gas would have eventually found a spark, a proactive approach might have provided precious seconds for workers to escape. All who died in the explosion were within 250 feet of the maintenance site.

Another factor contributing to the extensive plant damage was the inadequate water supply for fire fighting, as detailed in the Cause Map. When the plant was designed, the water system used in the HDPE process was the same one that was to be used in an emergency. There is no doubt a single water system was selected to keep costs down. Other shortcuts include placing regular-service fire system pump components above ground. Of course, the explosion sheared electrical cords and pipes controlling the system, rendering it unusable. Not only was the design of the fire system flawed, it wasn't even adequately maintained. In the backup diesel pump system, only one of three pumps was operational; one was out of fuel and the other simply didn't work. Because of these major flaws, emergency crews had to use hoses to pump water from remote sources. The fire was not brought under control until 10 hours after the initial explosion. As the Cause Map indicates, there may not have been such extensive damage had the water supply system been adequate.
