Fatal Highway Accident

Golden, Colorado
May 15, 2004

Cause Map High Level

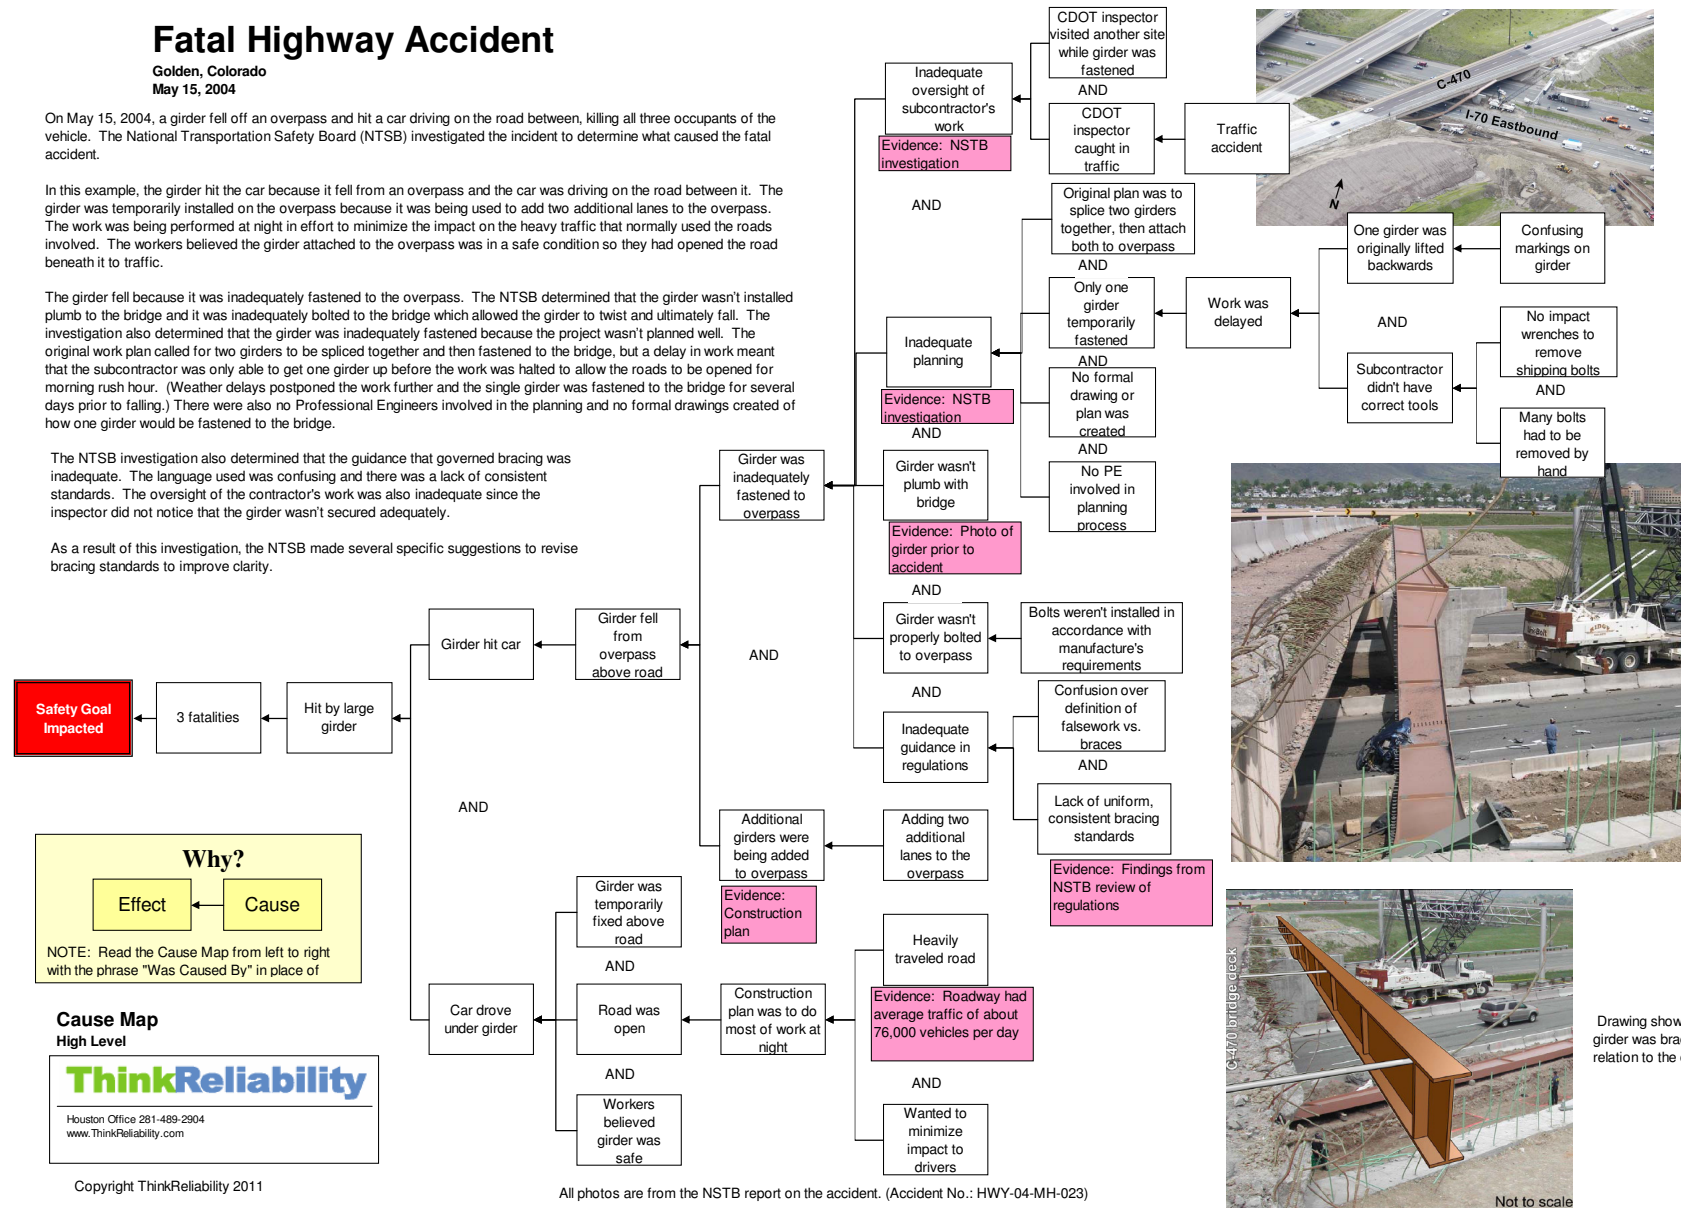
The girder fell because it was inadequately fastened to the overpass. The NTSB determined that the girder wasn't installed plumb to the bridge and it was inadequately bolted to the bridge which allowed the girder to twist and ultimately fall. The investigation also determined that the girder was inadequately fastened because the project wasn't planned well. The original work plan called for two girders to be spliced together and then fastened to the bridge, but a delay in work meant that the subcontractor was only able to get one girder up before the work was halted to allow the roads to be opened for morning rush hour. (Weather delays postponed the work further and the single girder was fastened to the bridge for several days prior to falling.) There were also no Professional Engineers involved in the planning and no formal drawings created of how one girder would be fastened to the bridge.

Drawing showing how the girder was braced in relation to the overpass.

As a result of this investigation, the NTSB made several specific suggestions to revise bracing standards to improve clarity.
