Step 1. Outline

**Bluff Collapse Releases Coal Ash
Lake Michigan, October 31, 2011**

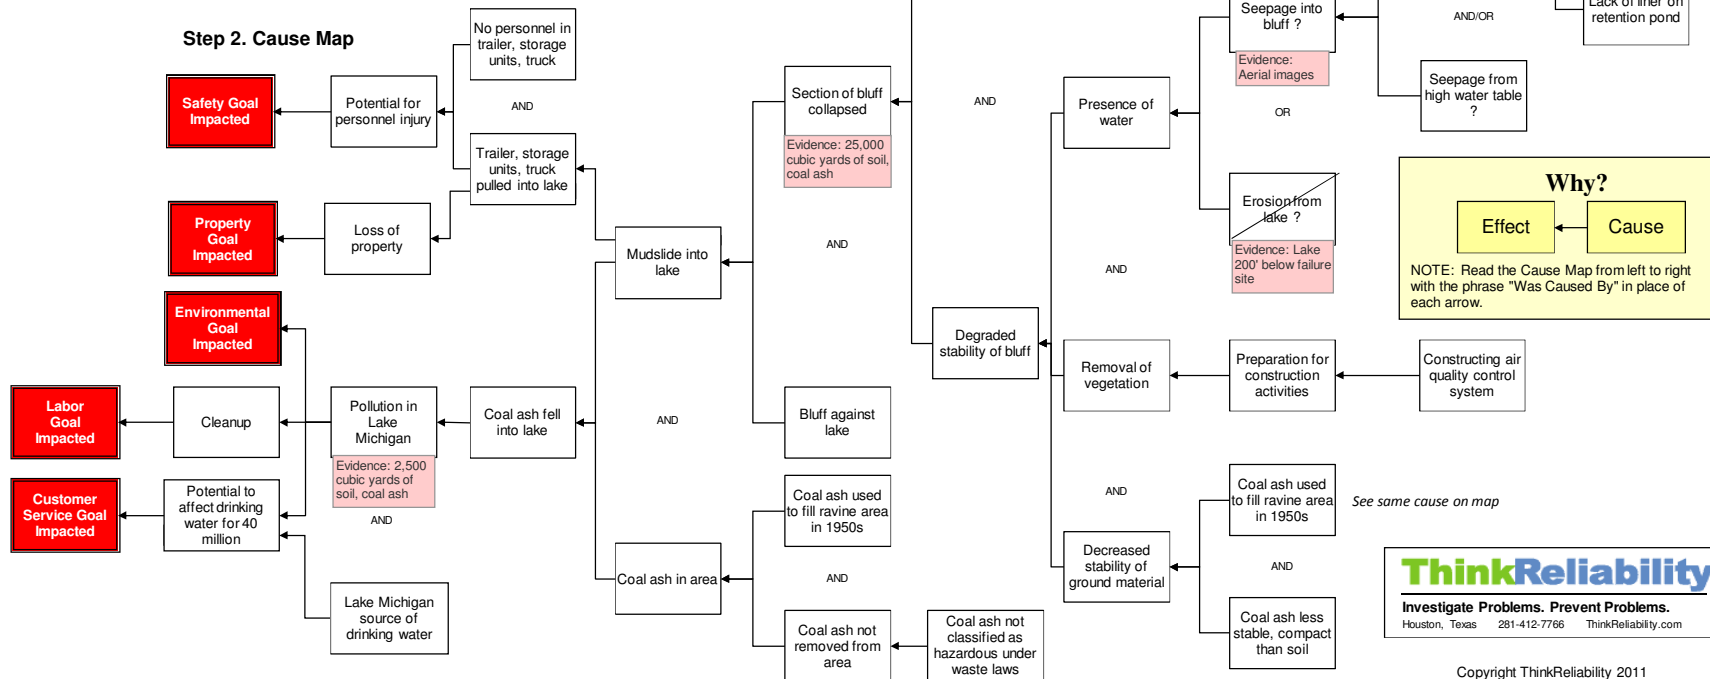
Step 2. Cause Map

Although the safety goal was not impacted by this incident, there was the potential for personnel injury. Additionally, the environmental, customer service, property and labor goals were impacted by the pollution of the lake, loss of property and necessary cleanup. The causes for these impacts to the goals can be examined in a Cause Map, or visual root cause analysis.
