The Phillips 66 Plant Explosion
Pasadena, TX
October 23, 1989

Step 2. Cause Map
High and Intermediate Levels

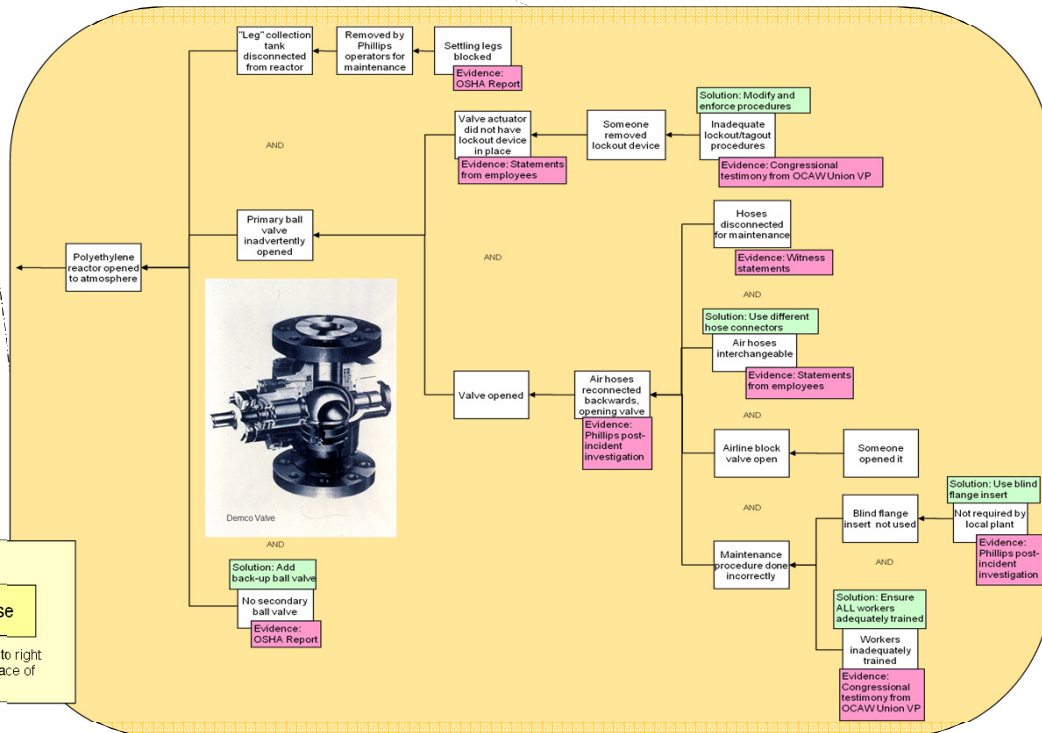
Looking at the Phillips 66 Explosion Cause Map, one can see how a series of procedural errors occurred that fateful day. Contract workers were busy performing a routine maintenance task of clearing out a blockage in a collection tank for the plastic pellets produced by the reactor. The collection tank was removed, and work commenced that morning. However, at some point just after lunch, the valve to the reactor system was opened, releasing an enormous gas cloud which ignited less than two minutes later.

To easily understand the underlying reasons behind the Phillips 66 Explosion of 1989, a high-level Cause Map provides a quick overview of the event. Breaking a section of the Cause Map down further can provide significant insight into the multiple reasons the event occurred. The associated PDF for this case shows how different levels of a Cause Map can provide just the right amount of detail for understanding complex problem such as this one.

The subsequent OSHA investigation highlighted numerous errors. First, the air hoses used to activate the valve pneumatically were left near the maintenance site. When the air hoses were connected backwards, this automatically opened the valve, releasing a huge volatile gas cloud into the atmosphere. It is unknown why the air hoses were reconnected at all. Second, a lockout device had been installed by Phillips personnel the previous evening, but was removed at some point prior to the accident. A lockout device physically prevents someone from opening a valve. Finally, in accordance with local plant policy but not Phillips policy, no blind flange insert was used as a backup. The insert would have stopped the flow of gas into the atmosphere if the valve had been opened. Had any of those three procedures been executed properly, there would not have been an explosion that day. According to the investigation, contract workers had not been adequately trained in the procedures they were charged with performing.

Additionally, there were significant design flaws in the reactor/collector system. The valve system used had no mechanical redundancies; the single Demco ball valve was the sole cut-off point between the highly-pressurized reactor system and the atmosphere. Additionally, there was a significant design flaw with the air hoses, as alluded to earlier. Not only were the air hoses connected at the wrong time, but there was no physical barrier to prevent them from being connected the wrong way. This is the same reason North American electrical plugs are mechanically keyed and can only be plugged in one way. It can be bad news if connected incorrectly! Connecting the air hoses backward meant the valve went full open, instead of closed. Both of these design flaws contributed to the gas release, and again, this incident would not have occurred if either flaw was absent.
