# The Phillips 66 Plant Explosion Pasadena, TX October 23, 1989

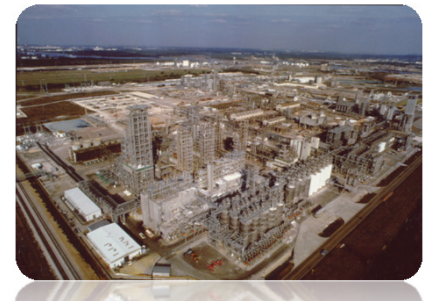
## Cause Map Intermediate Level

The Cause Map shows that the high number of fatalities was caused not only by the initial explosion. The OSHA investigation following the explosion highlighted contributing factors regarding the building layout. High occupancy structures, such as the control room and administrative building were located unnecessarily close to the reactors and storage vessels. Luckily over 100 personnel were able to escape via alternate routes. But luck is certainly not a reliable emergency plan; the plant should have been designed with safety in mind too.

Nearby ignition sources also contributed to the speed of the initial explosion, estimated to be within 90 to 120 seconds of the valve opening. OSHA cited Phillips for not using due diligence in ensuring that potential sources of ignition were kept a safe distance from flammable materials or, alternatively, using testing procedures to ensure it was safe to bring such equipment into work zones. The original spark source will never be known, but the investigation identified multiple possibilities. These included a crane, forklift, catalyst activator, welding and cutting-torch equipment, vehicles and ordinary electrical gear. While undoubtedly such a large cloud of volatile gas would have eventually found a spark, a proactive approach might have provided precious seconds for workers to escape. All who died in the explosion were within 250 feet of the maintenance site.

Another factor contributing to the extensive plant damage was the inadequate water supply for fire fighting, as detailed in the Cause Map. When the plant was designed, the water system used in the HDPE process was the same one that was to be used in an emergency. There is no doubt a single water system was selected to keep costs down. Other shortcuts include placing regular-service fire system pump components above ground. Of course, the explosion sheared electrical cords and pipes controlling the system, rendering it unusable. Not only was the design of the fire system flawed, it wasn't even adequately maintained. In the backup diesel pump system, only one of three pumps was operational; one was out of fuel and the other simply didn't work. Because of these major flaws, emergency crews had to use hoses to pump water from remote sources. The fire was not brought under control until 10 hours after the initial explosion. As the Cause Map indicates, there may not have been such extensive damage had the water supply system been adequate.
