GROUNDING THE 737'S

Cause Map Emergency Descent of SWA Flt 812

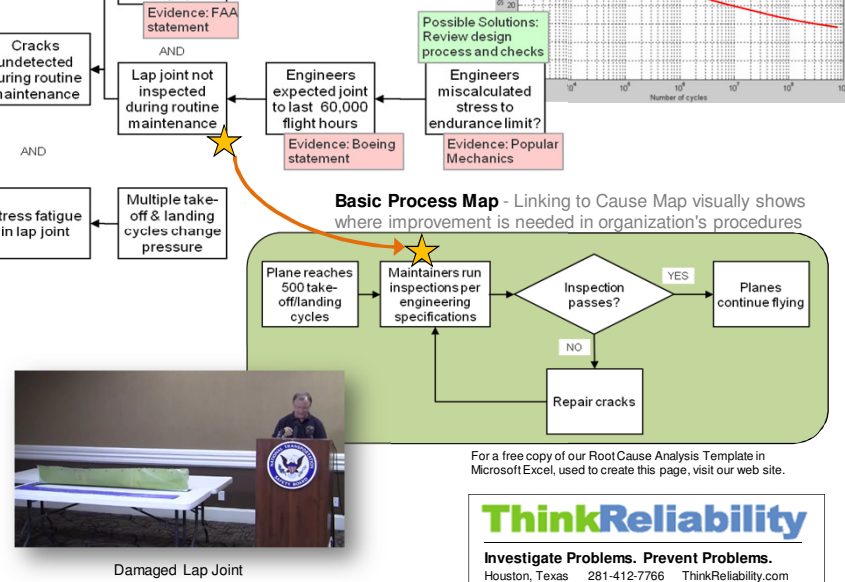
More Detailed Cause-and-Effect

While the investigation is still in the early stages, it appears that stress fatigue caused a lap joint near the top of fuselage to fail. Stress fatigue is a well known phenomenon, caused in aircraft by the constant pressurization and depressurization occurring during takeoff and landing. Mechanical engineers would have been well aware of this phenomenon. The S-N curve, which plots a metal's expected lifespan vs. stress, has been used for well over a century.

Just as a car needs preventative maintenance, planes are checked regularly for parts that are ready to fail. However, the crack in lap joint wasn't detected during routine maintenance. Often the design engineers are also set the maintenance schedule, because they hold the expertise needed. The engineers didn't expect the part to fail for at least 20,000 more flight hours. At the moment, it's unclear why that is.

In response to the incident, the FAA has grounded all similar aircraft and ordered inspections of flights nearing 30,000 flight hours.
