Canal Failure - Homes Flooded

Fernley, Nevada

January 5th, 2008

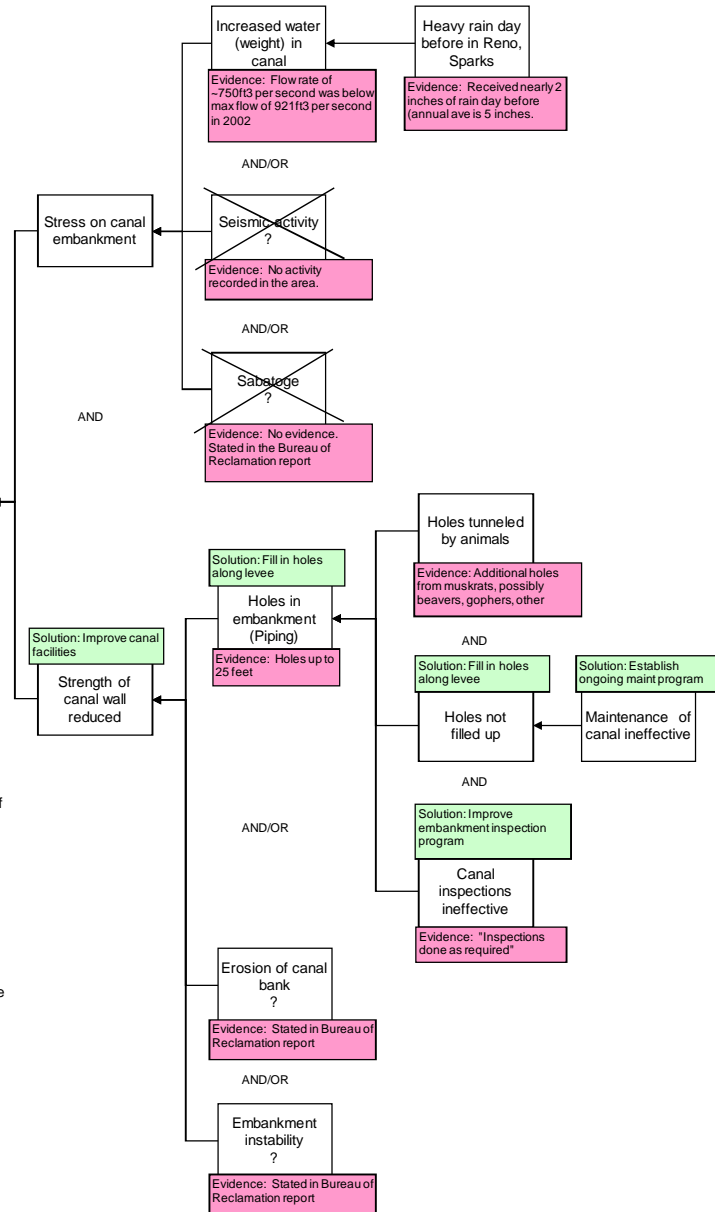
The Cause Map shows that the canal obviously failed because the stress on the embankment was greater than the strength of the embankment. The increased water flow added to the stress on the embankment while the holes tunneled by the rodents reduced the strength. A thorough root cause analysis built as a Cause Map can capture all of the causes in a simple, intuitive format that fits on one page.

This is an intermediate level root cause analysis of the canal failure. It includes causes that were considered in the Bureau of Reclamation report as well as some of the evidence and solutions. A more detailed Cause Map can be created from the specific information in the bureau's report.

Since the canal is almost 100 years old tunneling muskrats are not a surprise. If the holes would have been identified earlier and filled, the risk of the breach would have been reduced significantly. The evidence that the inspection and maintenance of the canals was ineffective is the fact that the canal failed due to holes. An effective inspection program would have found the holes and addressed them - that's the purpose of inspection and maintenance. Past inspections may have been conducted exactly as required, which simply means the previous inspection requirements were inadequate. Ineffective inspections is one of the causes of the canal failure that would need to be investigated further.
